Subject: 2015 Annual Progress Report
K/J 006014.01 and 966124.34

Enclosed is the 2015 Annual Progress Report for the South Tacoma Field site. Inspection and sampling activities were conducted in December 2015 and January 2016 to evaluate current conditions at the site. For reference, we have attached three figures from the Operation and Maintenance (O&M) Plan for the site to help orient you on the location of annual O&M activities addressed in this report. **We request consideration in deleting the Amsted portion of the site from the National Priorities List since contaminants have not been detected in groundwater above cleanup levels over the past ten years.**

SITE NAME: South Tacoma Field, Tacoma, Washington

STF Monitoring Well Replacement Memo

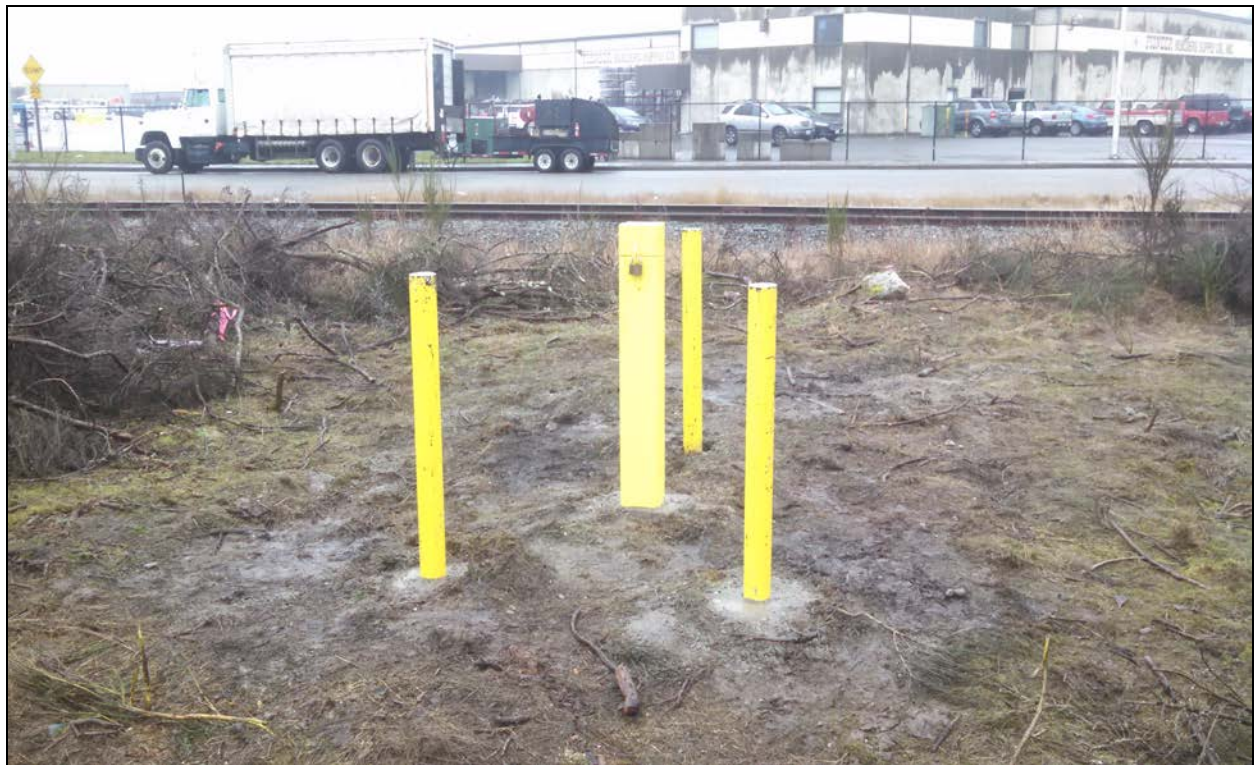
New Well STM-1A1. View to the northwest.

A replacement well for STM-1A was installed on 4 January 2016 approximately five feet south of the original well location. The new well was designated STM-1A1 and was installed to a depth of 40 feet below ground surface (bgs) with using 2-inch diameter PVC well construction materials including 20 feet of 0.010-inch slotted well screen. Well STM-1A1 was completed with a steel stand-pipe monument with three protection posts.

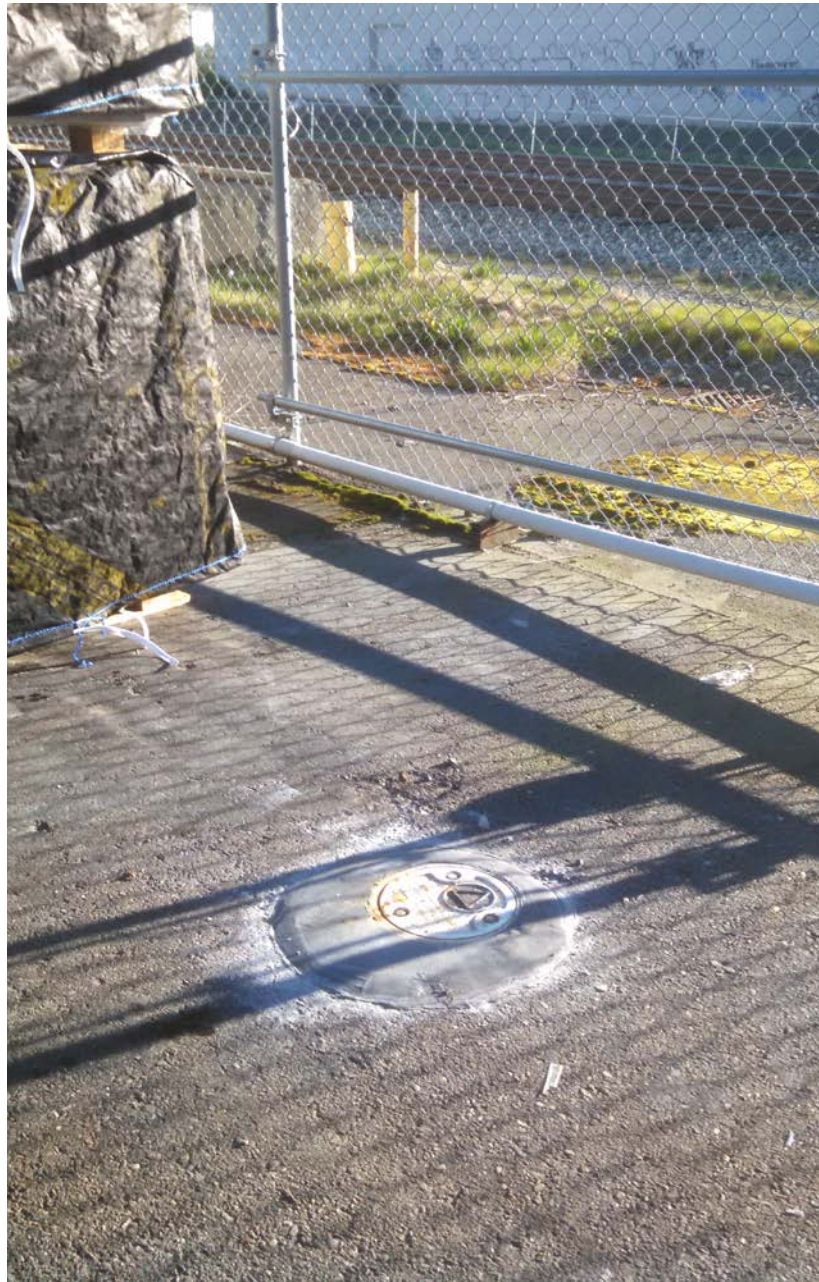
| ITEM | ITEMS TO MEASURE OR NOTE | OBSERVED CONDITIONS/MEASUREMENT | MAINTENANCE OR CORRECTIVE ACTION REQUIRED |
|---|--|--|--|
| Damage/Vandalism | Which wells? | Well STM-1A is damaged as per previous inspections and is unusable. Pioneer Builders Supply well NMW-8A is also damaged per previous inspections, with the stand-pipe monument tipped by 5-10 degrees and the northern protection post removed. Other wells are intact. | Wells NMW-8A and STM-1A will be abandoned and replaced with new wells in early 2016. The new wells (STM-1A1 and NMW-8A1) will be included in the next monitoring event. No other corrective action required at this time. |

New Well NMW-8A1 (surface monument in foreground) and existing well NMW-8A (yellow stand-pipe on opposite side of fence). View to the northwest.

Well NMW-8A1 was installed on the Pioneer property on 5 January 2016, approximately 15 feet southwest of NMW-8A. The new well was designated NMW-8A1 and was installed to a depth of 40 feet bgs with using 2-inch diameter PVC well construction materials including 20 feet of 0.010-inch slotted well screen. Well NMW-8A1 was completed with a steel surface-flush monument set in concrete. The new well was installed immediately west of the eastern Pioneer fence line, and is intended as a replacement for well NMW-8A which is located in the Sound Transit right-of-way east of Pioneer. NMW-8A was not decommissioned at the time because it

We anticipate that MWW-8A will be abandoned, as described in the Work Plan, by late spring of 2016, following review of analytical and gradient data for the Pioneer wells.
